THE
GREAT EARTHQUAKE
OF JAPAN

1891.

BY
JOHN MILNE.
AND
W.K. BURTON.
PLATES BY K. OGAWA.

JOHN MILNE, F.R.S. PROFESSOR OF MINING AND GEOLOGY ; IMPERIAL UNIVERSITY OF JAPAN,

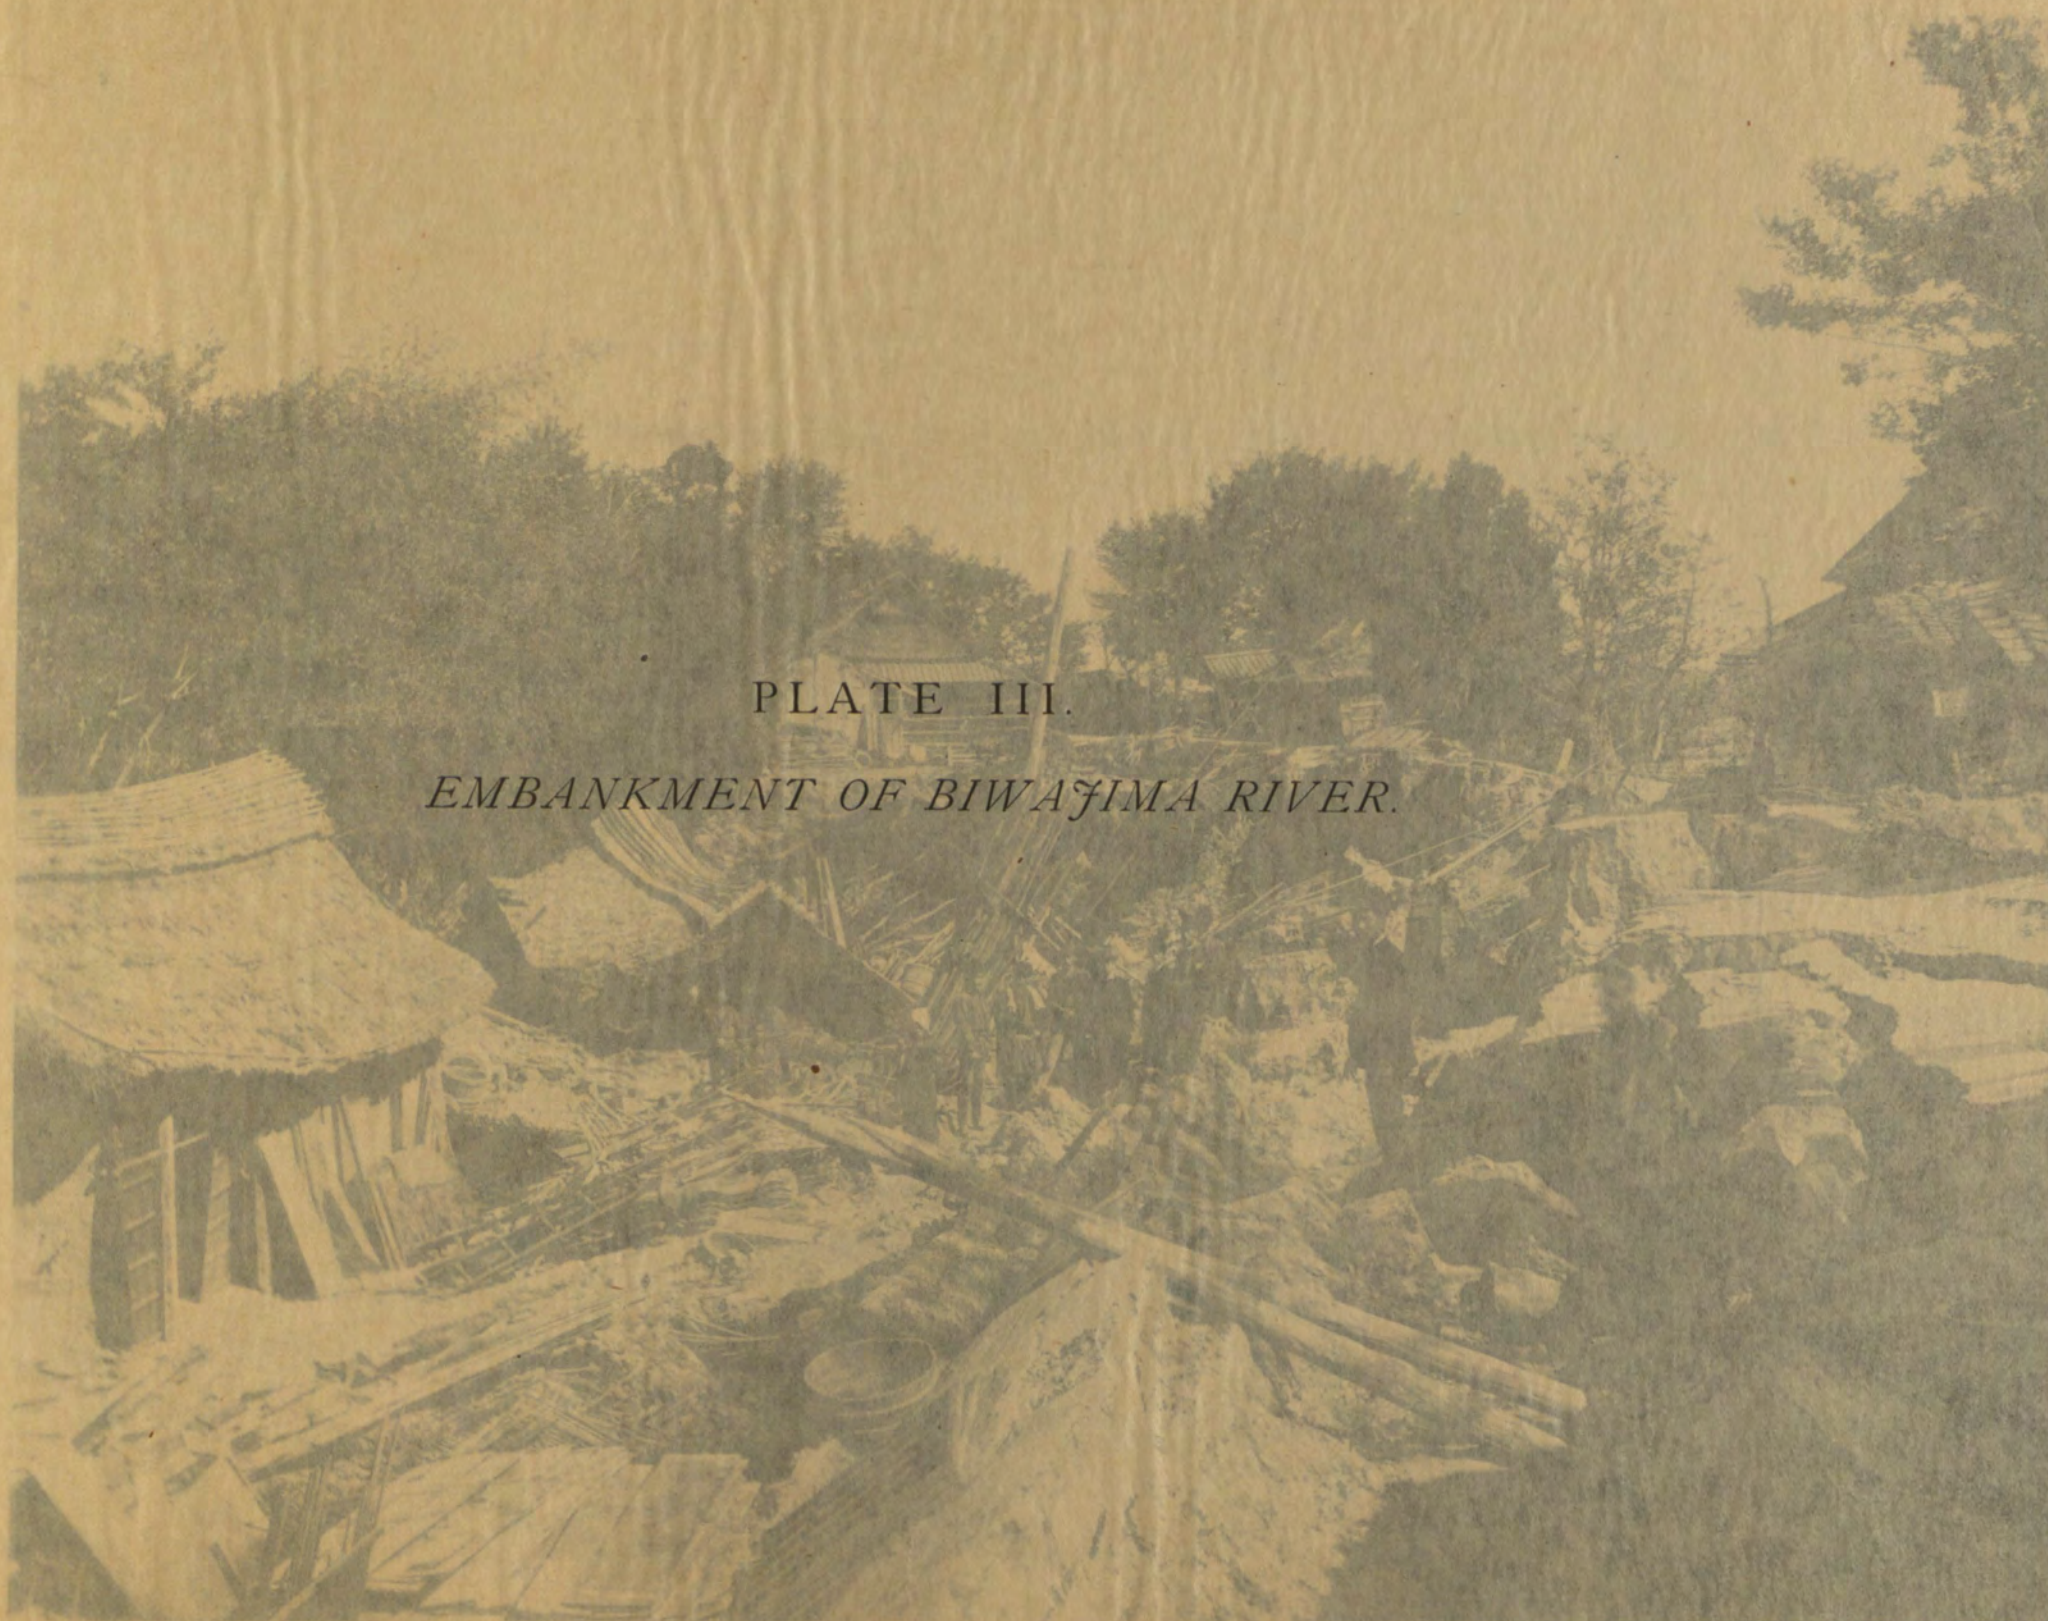
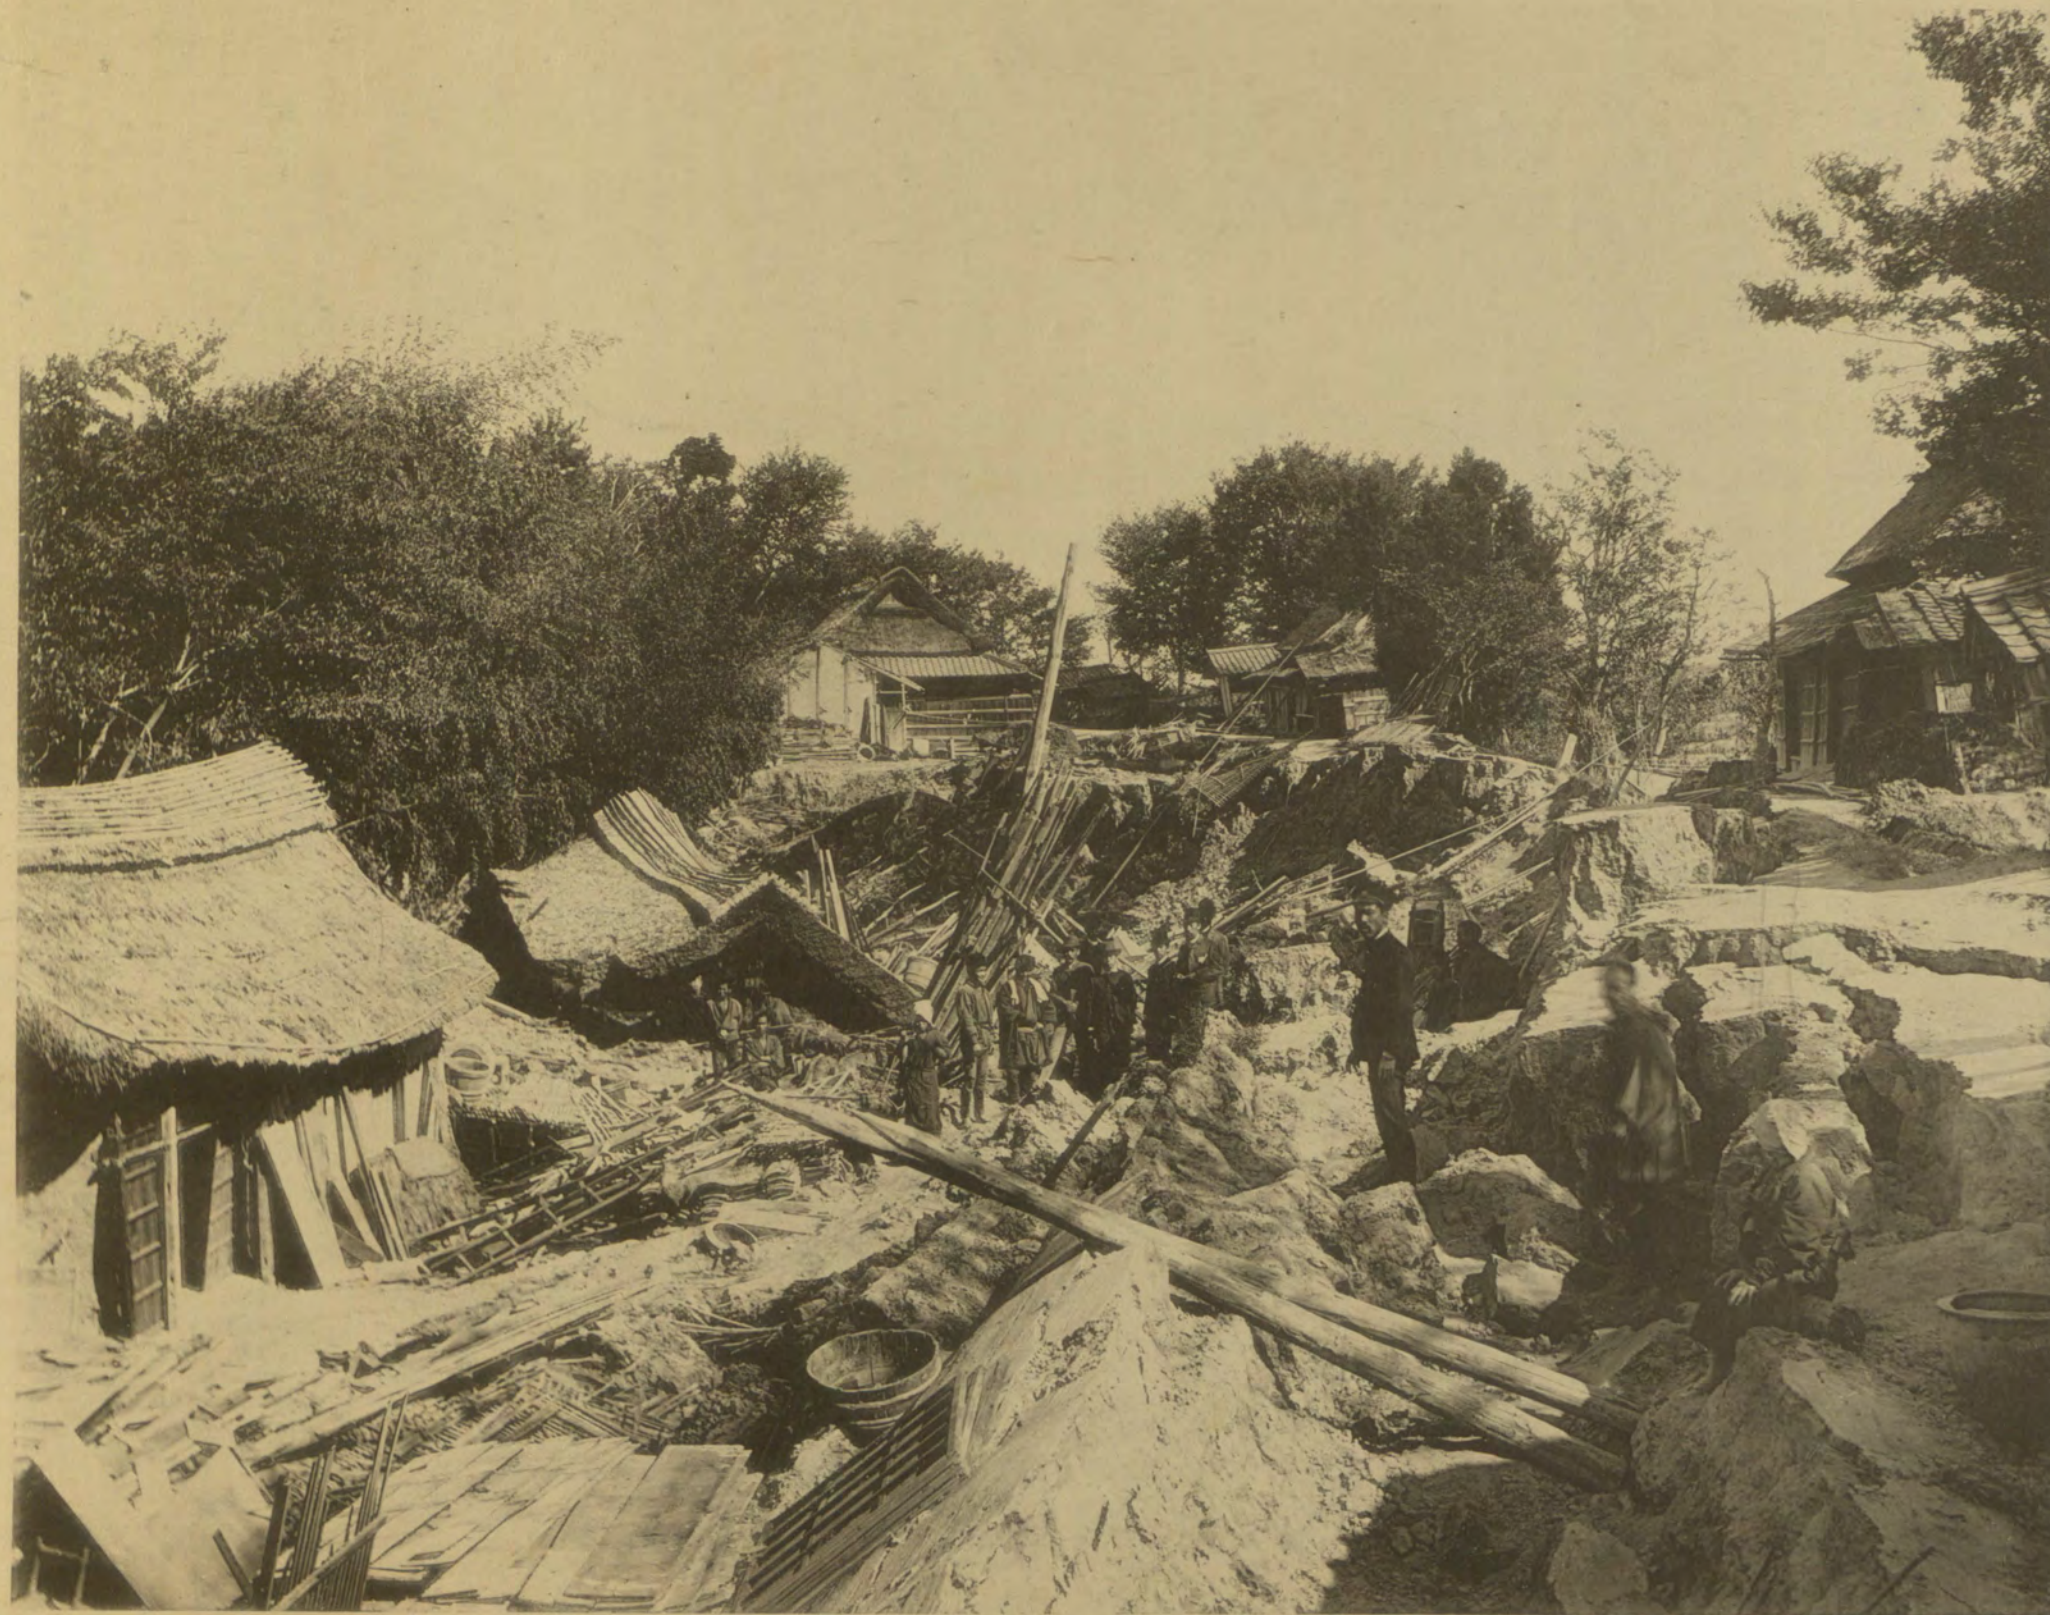
PLATE III.

The fracture shows the kind of destruction which has occurred along the banks for a distance of several miles near Biwajima. There are innumerable longitudinal clefts of all widths up to about two feet, and the inner half of the embankment has slid down towards the river to greater or less distances from a few inches to a number of feet measured vertically.

At one place the embankment is entirely gone for a couple of hundred feet or so, and here a very strange thing has happened. There was a large bamboo grove and a few pine trees just at the back—the side away from the river—of the embankment, and this little forest has slid,—been pushed or call it what you will—sixty feet back, yet the bamboos and trees remain upright!

One thatched roof, it will be noticed, has fallen intact, and it is in this manner that most of the farmers houses, which so thickly cover the Nagoya-Gifu plain, have given way and the country is now dotted over with these roofs, which from a distance present the appearance of gigantic saddles.

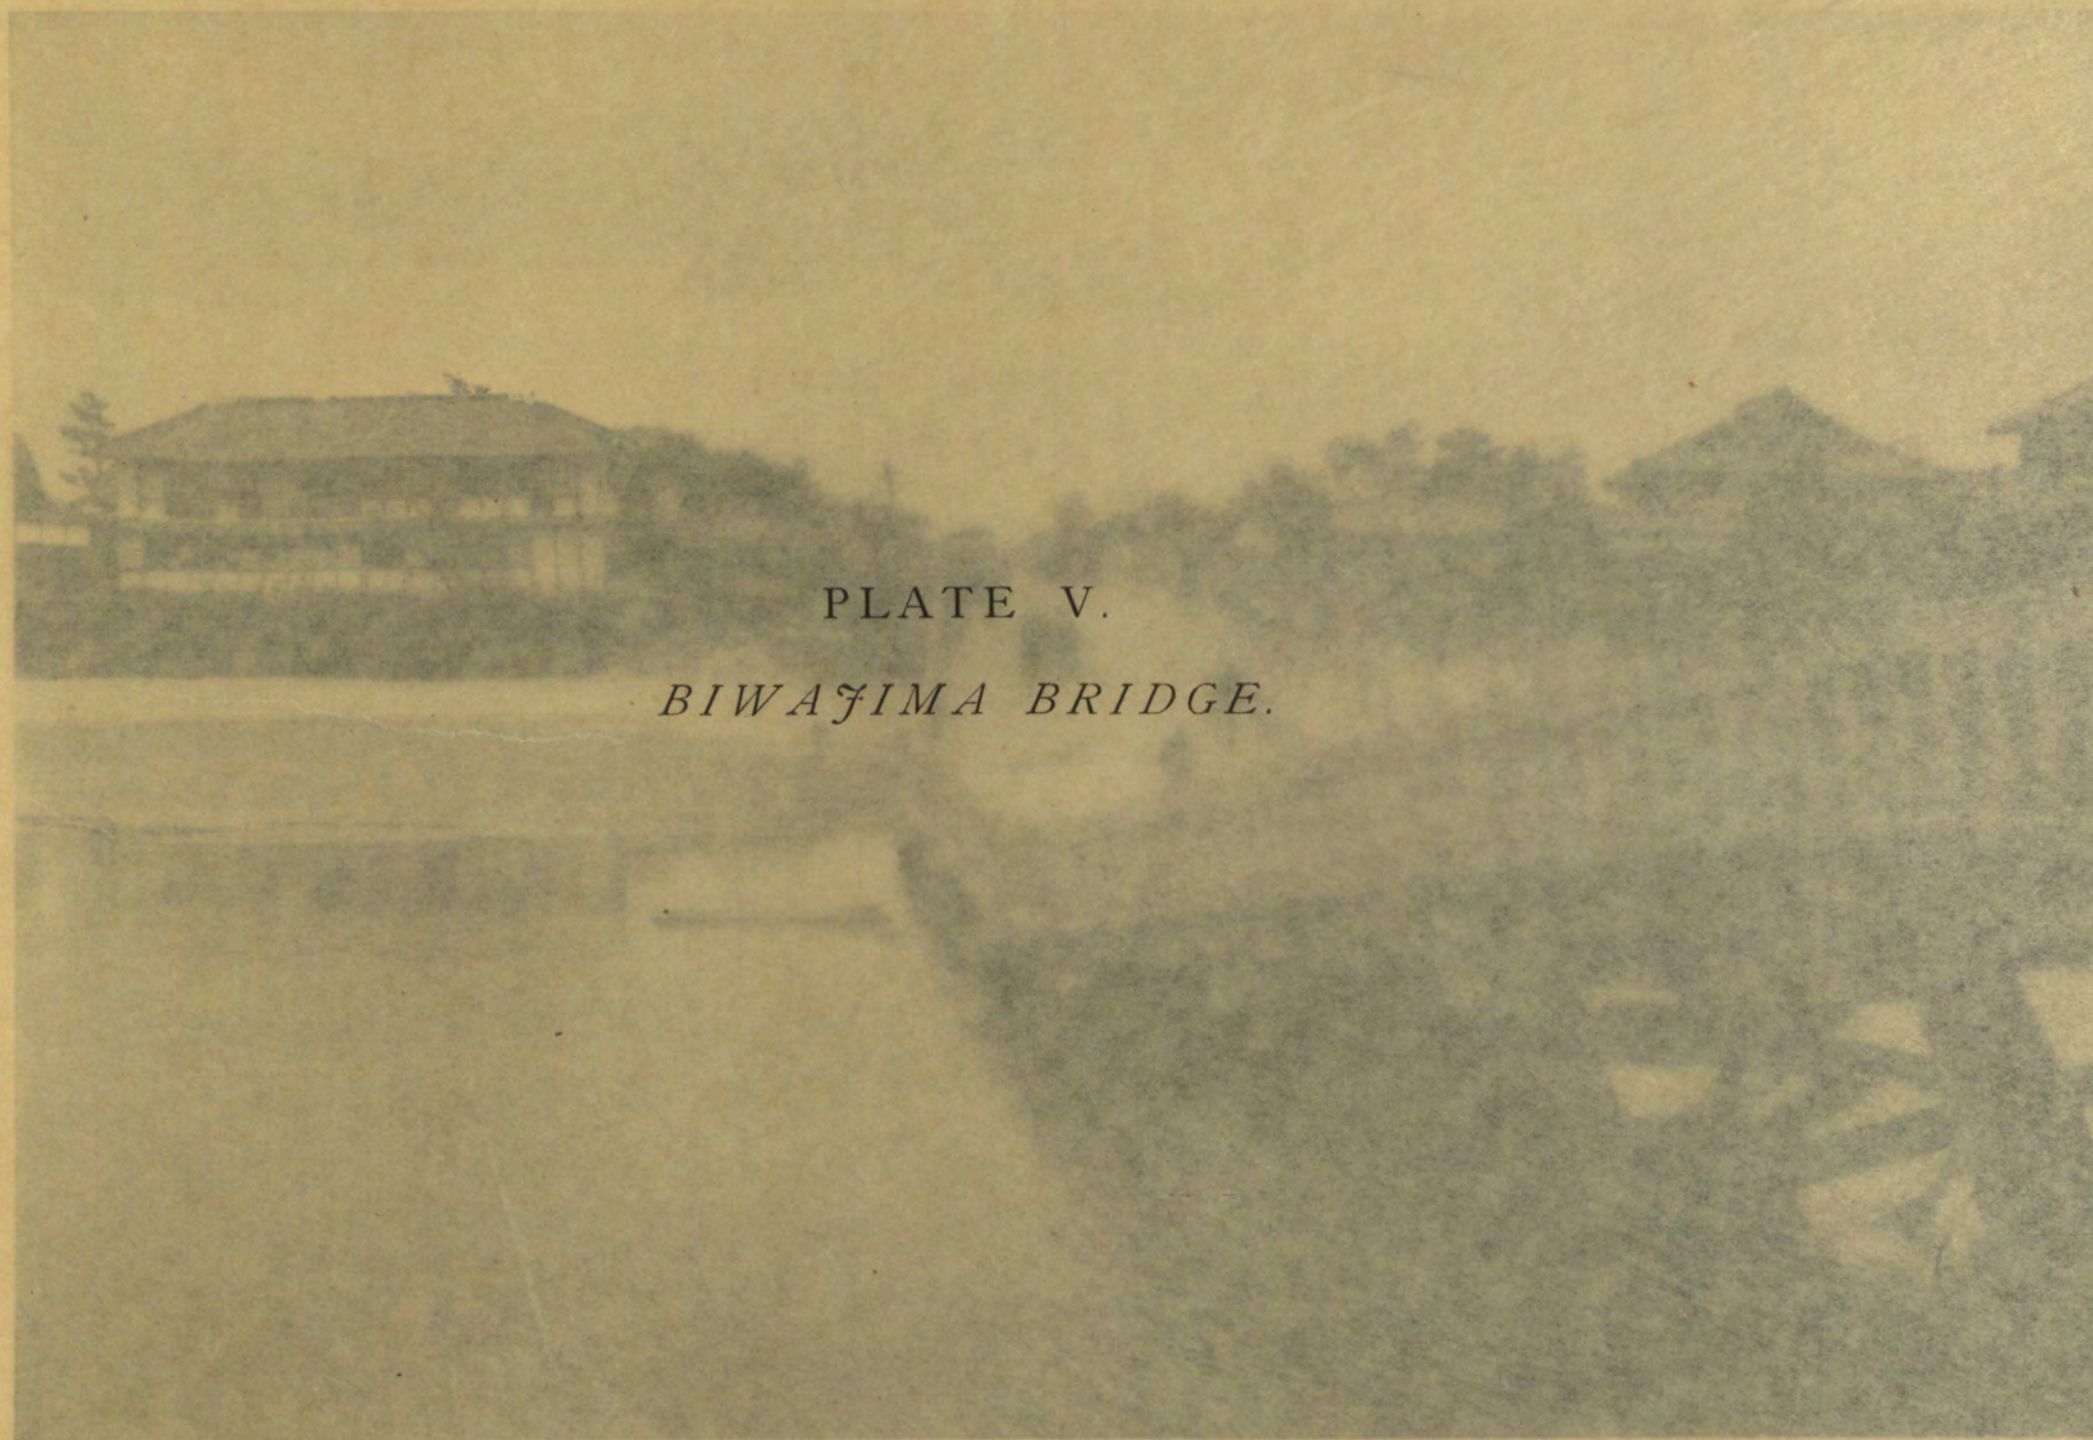
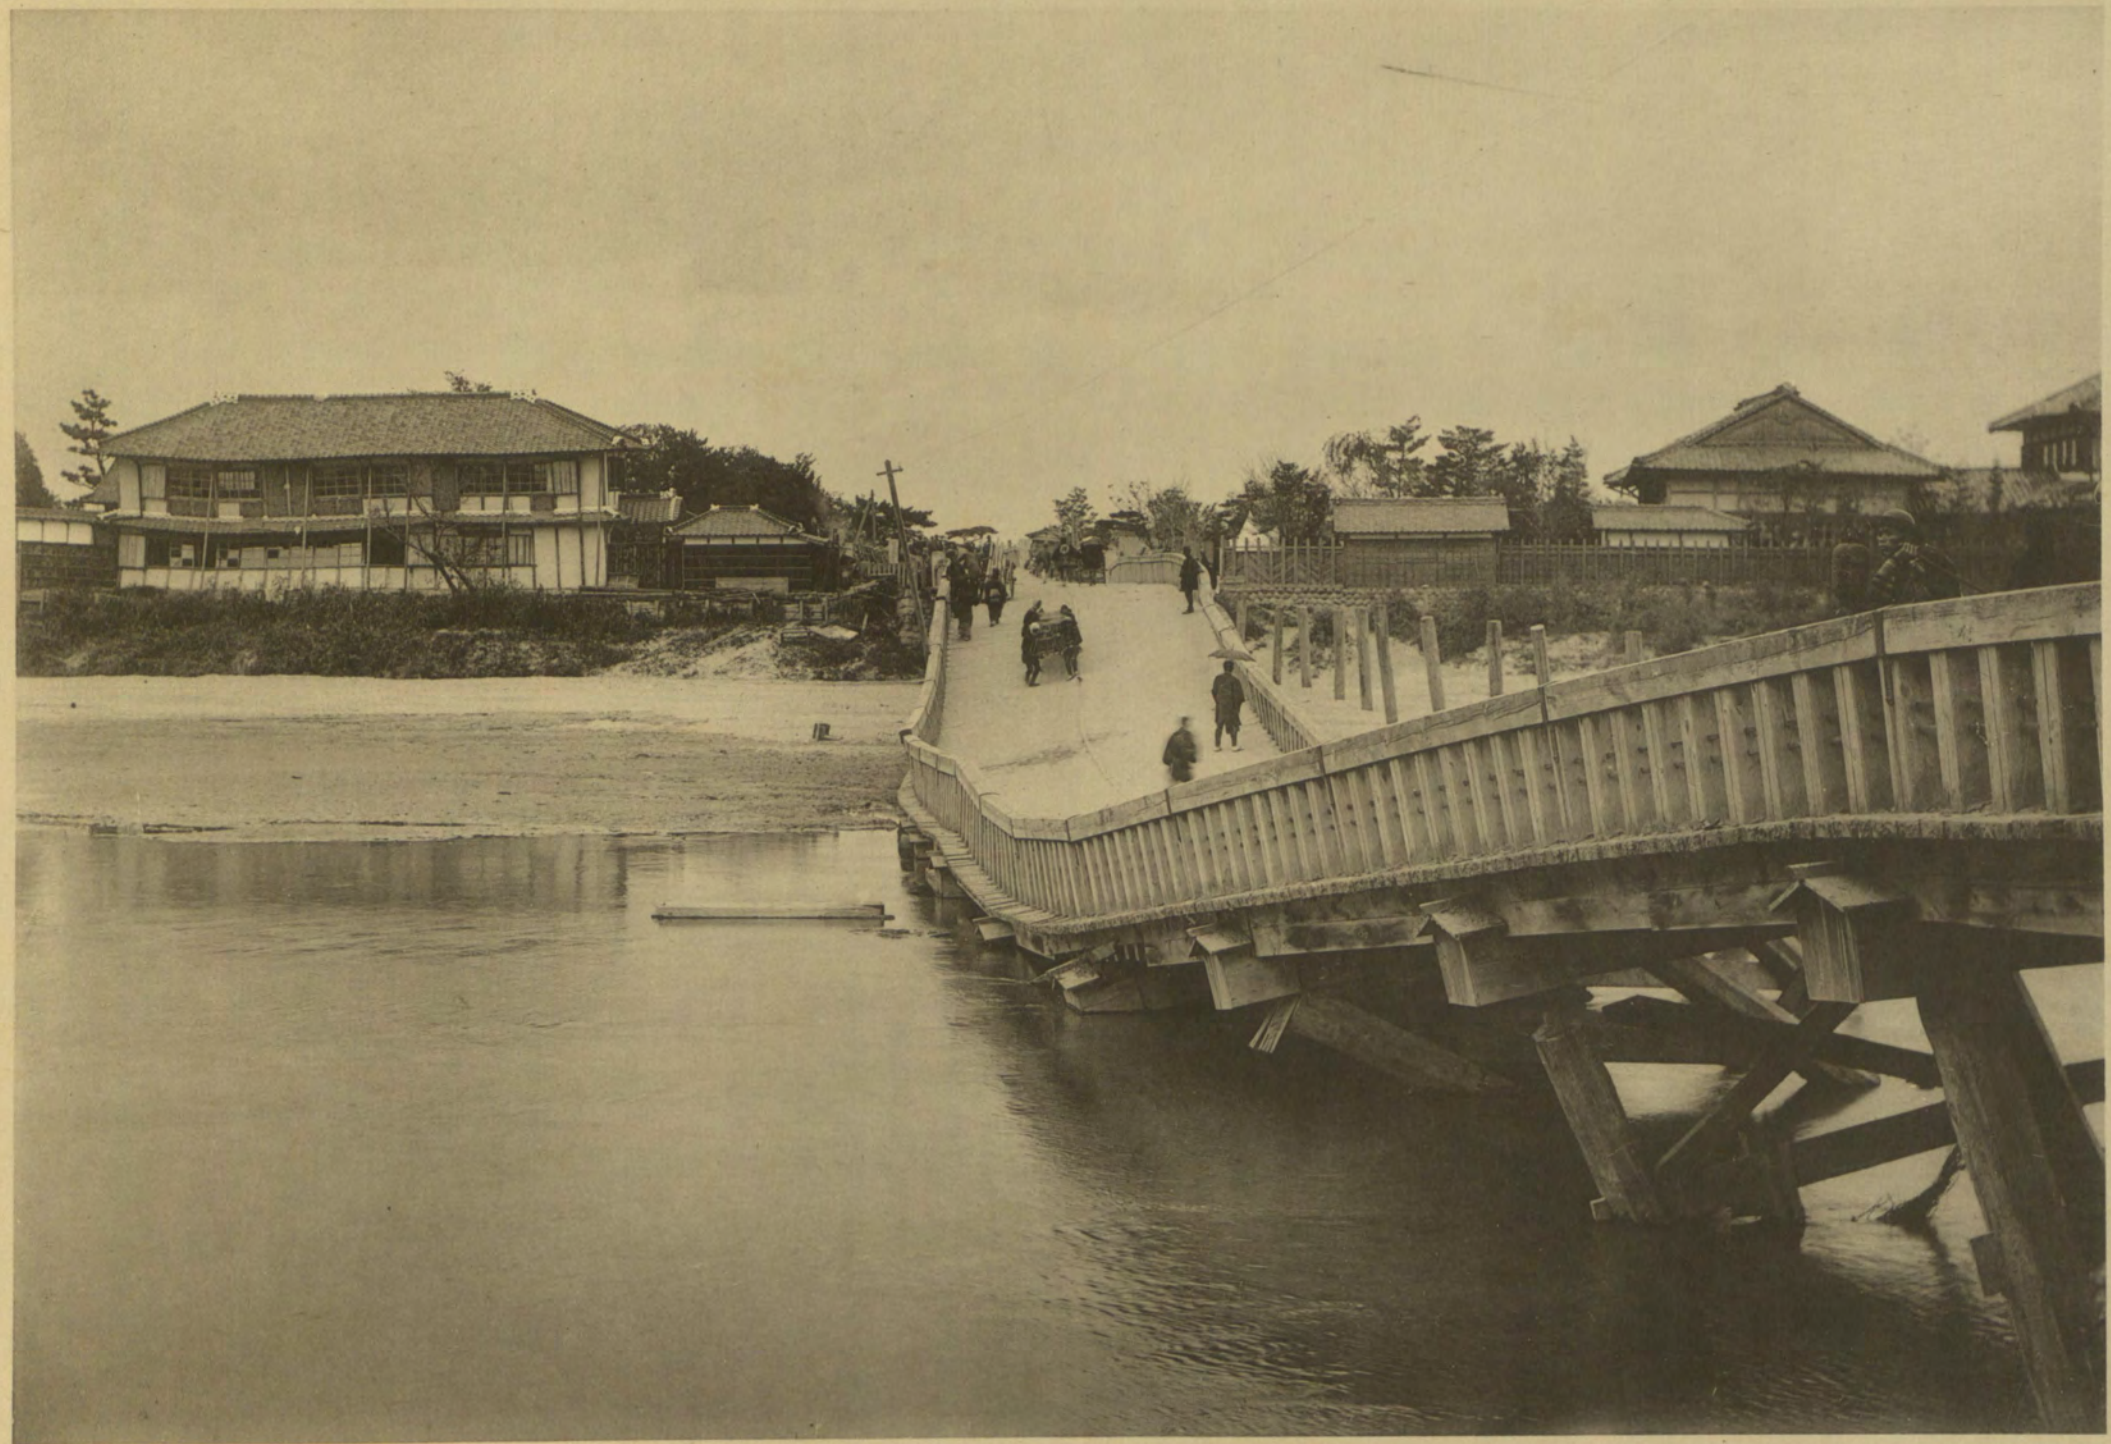
PLATE V.

HE Biwajima-bashi, a wide wooden carriage bridge across the Shōnaigawa, has been completely wrecked. It lies in the bed of the river in a curious serpent-like twisted form. The river is very low, and the continuity of the bridge is nowhere actually broken, so it is possible to walk across, though the feat is not a very easy one on account of the angle at which the footway is canted.

The river banks and the houses standing on them are fairly intact, suggesting the idea—which is, however, difficult to conceive—that the river bed had transmitted a greater quantity of motion than the banks.

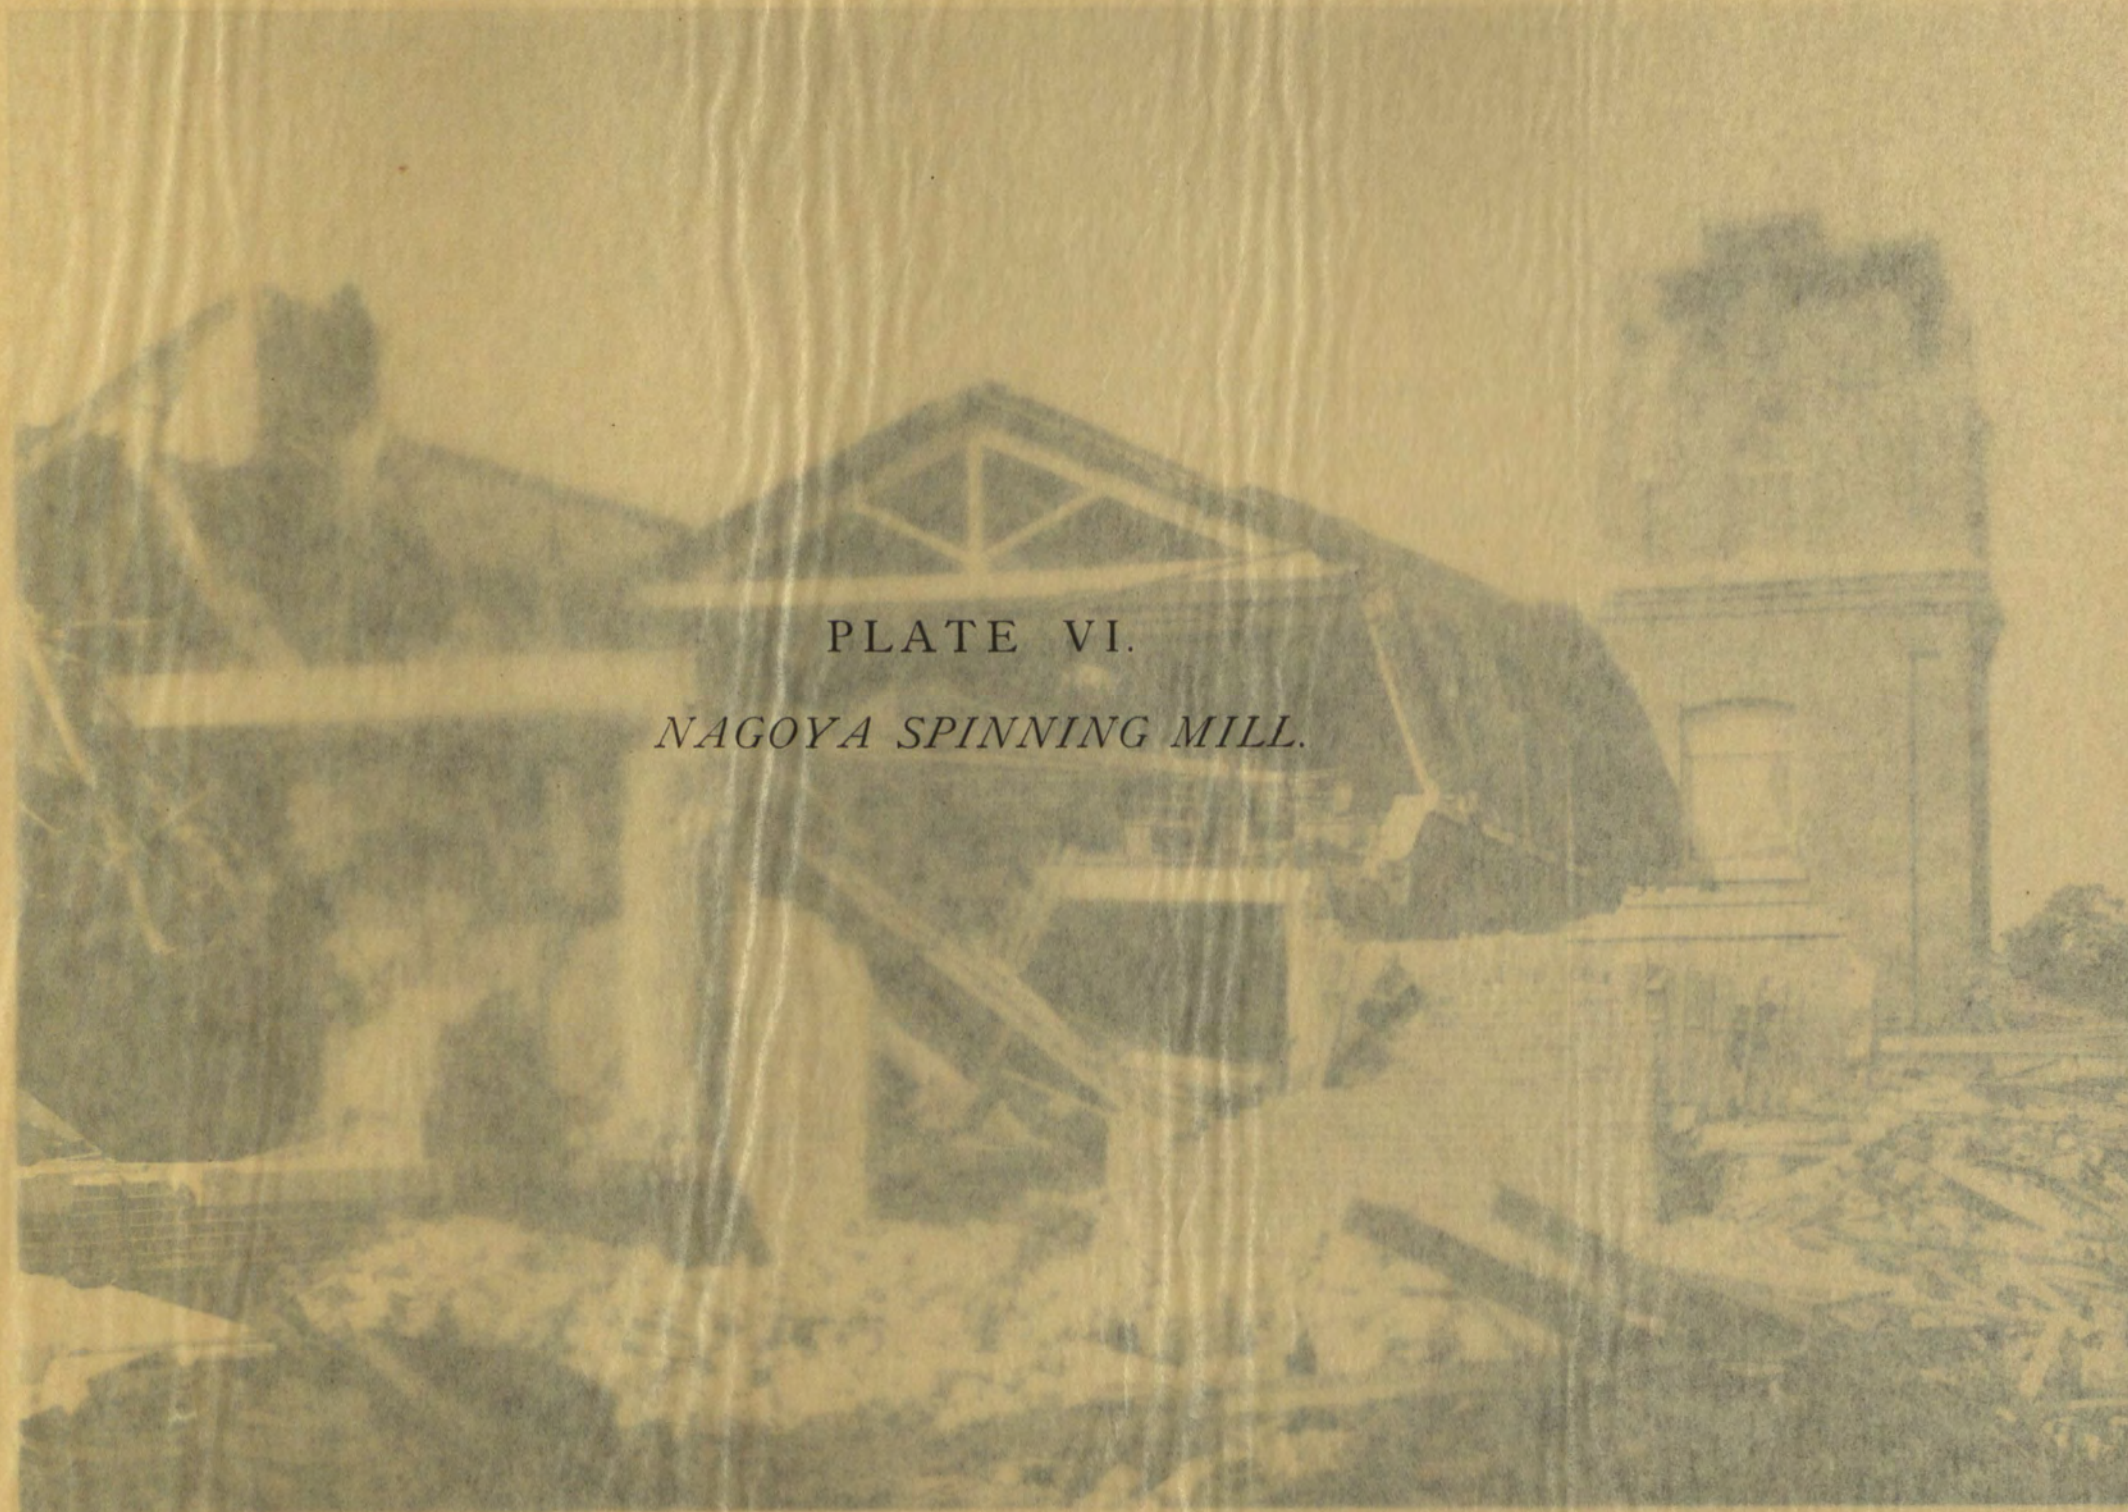
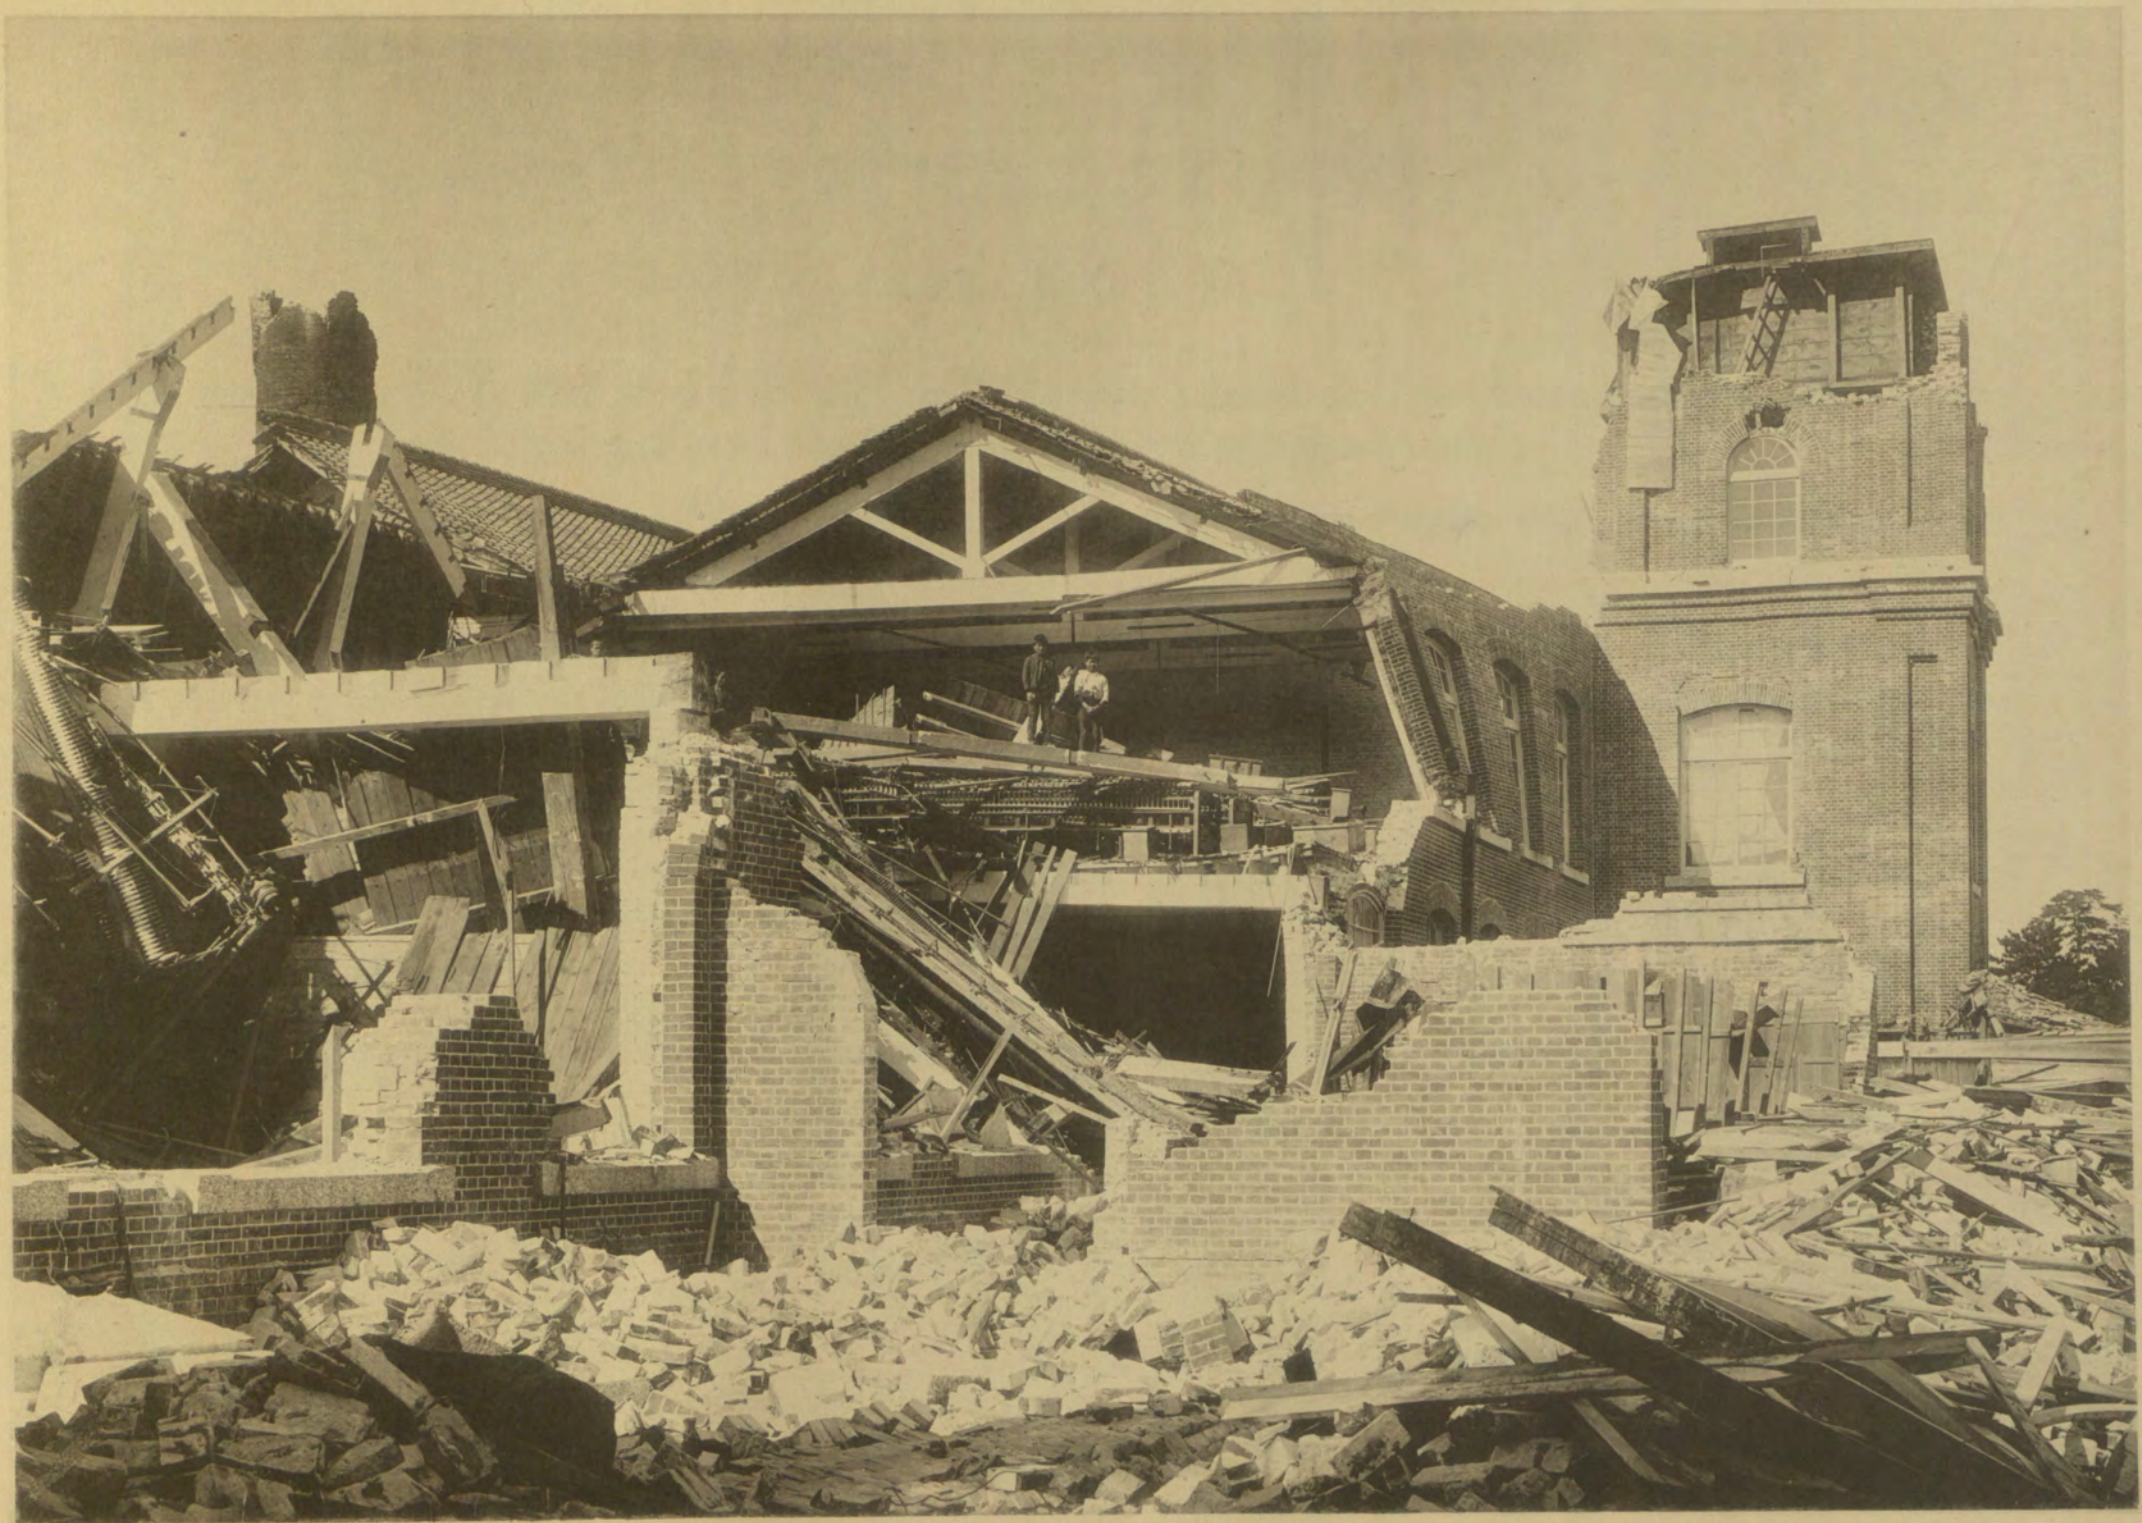
PLATE VI.

The building is in a terribly wrecked condition; there are not more than about half the walls standing, and these are cracked, twisted, and half overset.

In looking at the picture, it will be observed that, although the walls are fairly thick, from the way the bricks have separated we may imagine that the cohesive power of the mortar was not very great.

The cracks above the windows in the tower show that openings in walls form lines of weakness, and, as such, they require special consideration from the builder.
